Fairmount Park System

Natural Lands Restoration Master Plan

Park-Specific Master Plans

Cobbs Creek Park

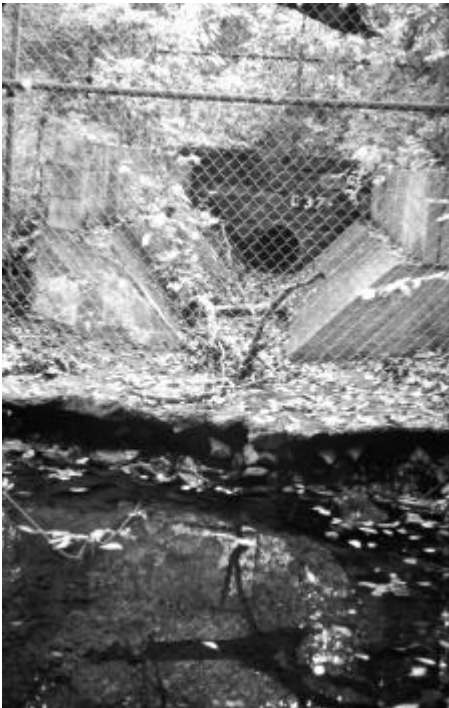
Outfall structure.

A stream is only as healthy as the watershed from which it flows. Cobbs Creek and its tributaries show the effects of an urbanized watershed. The streams have experienced many hydrologic changes that can be attributed to the conversion of a native forested watershed to a highly urbanized and impervious watershed. The flows in the streams of Cobbs Creek Park are flashy. The vast amount of impervious surfaces in the watershed restricts rainwater from following its normal path of infiltration to ground water to surface water. Groundwater is depleted, causing low base flows (perennial, dry-season flows) in Cobbs Creek, while storms generate much runoff which leads to significantly increased stream flows. These changes to stream flow have

altered stream channels to the point where some streams and portions of streams in Cobbs Creek Park cannot provide adequate aquatic habitat. However, several small streams are in better condition. Some streams have watersheds almost completely within the park boundaries, which protects them from some of the impacts of urbanization. The Habitat Quality Map, Volume II, Section 1, illustrates the habitat quality and the urbanization impacts of each stream in Cobbs Creek Park, as determined by the screening-level assessment.

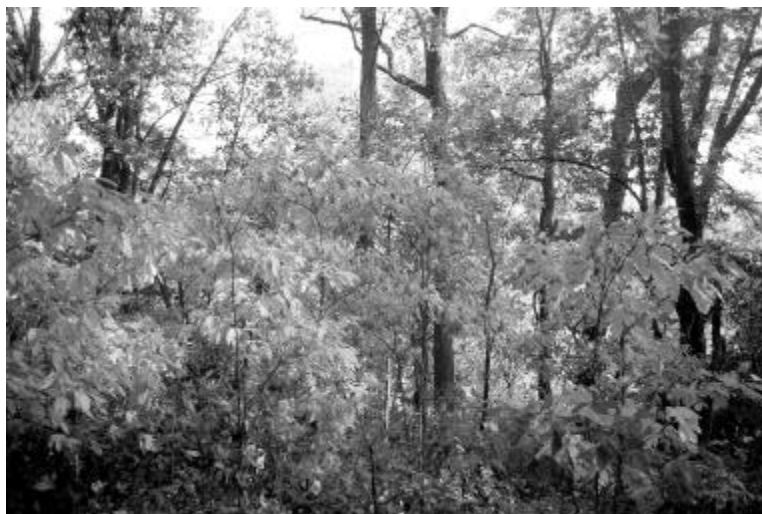
Thriving and reproducing understory, Cobbs Creek Park.

Forested uplands have been fragmented in recent years by adjacent construction activities, overall development and park landscaping. Not only does the forested upland habitat type support plants and animals, it also acts as a buffer for stormwater runoff and prevents slope erosion. In Cobbs Creek Park there are unique patches of woods generated by land use history, soil composition, moisture requirements and the effects of herbivory on vegetation at different sites. Large stands of

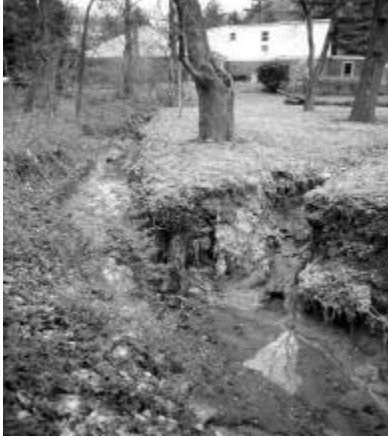
Riparian zone of small tributary, Cobbs Creek Park.

In the Fairmount Park system, the areas adjacent to the creeks have been used by the public as picnic areas, bike trails, and fishing points. The natural vegetation of these riparian zones has been altered in such a way that they are no longer able to function as they should. Due to this disturbance, an exotic plant species, Japanese knotweed (*Polygonum cuspidatum*) has invaded the banks of the creek. This is evident in Carroll Park along the Cobbs Creek main stem and in Morris Park along the banks of Indian Creek and Indian Run and along lower Cobbs Creek. This plant reproduces vegetatively through rhizomes and is able to outcompete native riparian vegetation. It has a shallow root mass and therefore is not able to stabilize the banks as effectively as native tree species could. This makes the banks more vulnerable to erosion during a storm event. The more soil that becomes exposed, the more area this plant has to invade. The restoration activities for riparian zones in this project include removing

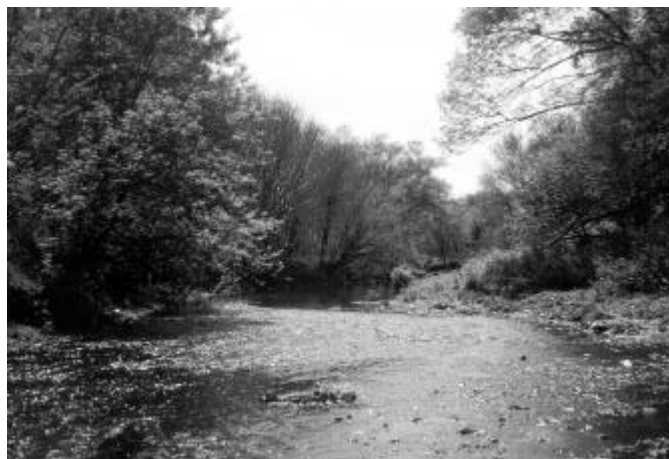
Main stem of Cobbs Creek.

Proposed restorations were classified as “channel” type if the activity is intended to restore a stream within its channel or along its banks. The types of “channel” restoration actions include: protect/enhance, trash removal, bank stabilization/regrade/riparian, modify channel, infiltration/berms, detention basin, daylighting, dam modification, dam removal, structural improvements (trails and stormwater), and fish reintroduction. A given restoration site may involve one or more of these actions, depending on site-specific conditions (Volume II, Sections 1 and 2 - Restoration Sites). The overriding objective for channel restoration is to
