2. TACONY CREEK PARK MASTER PLAN

Natural Lands Restoration

Master Plan

Tacony Creek Park

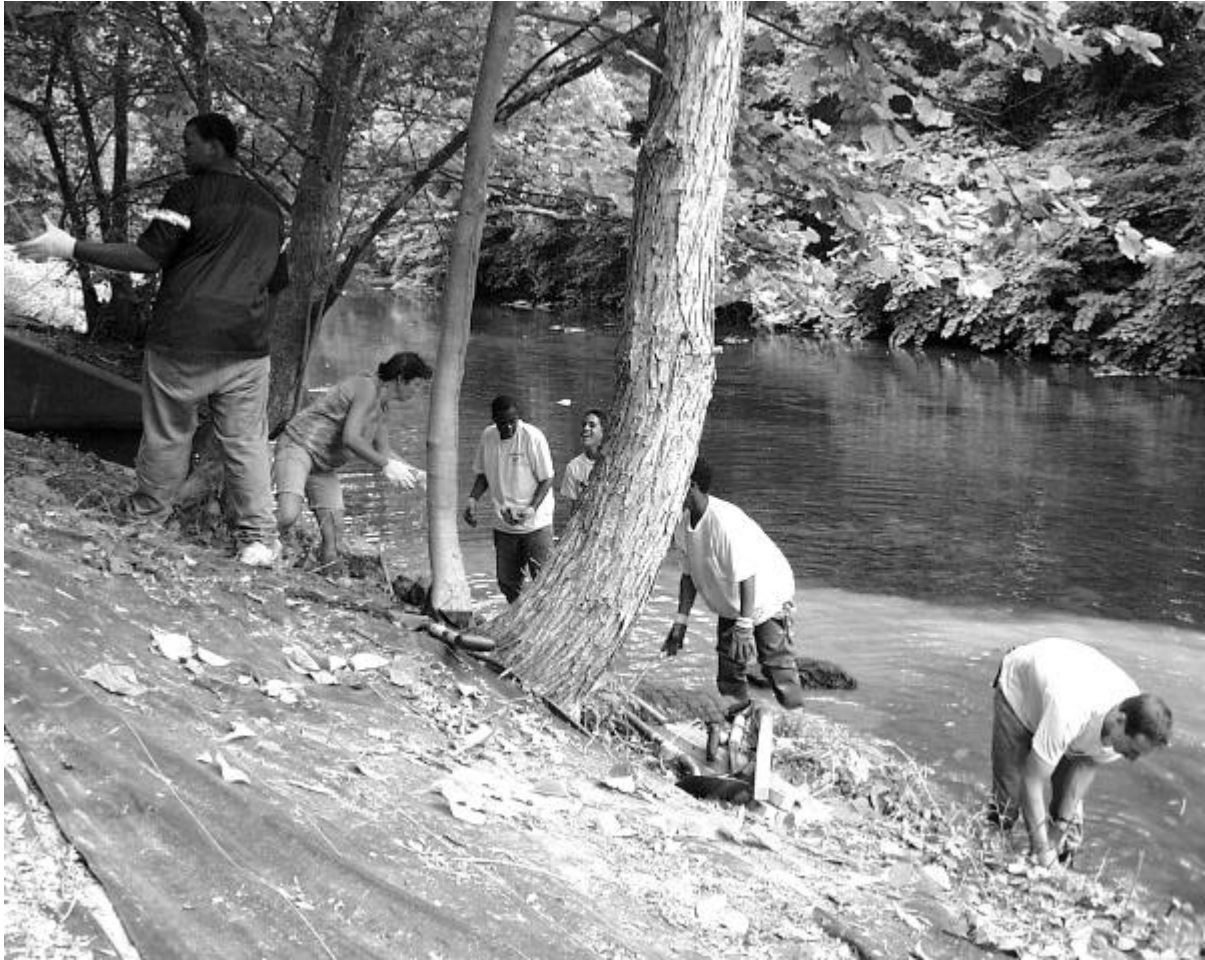
Stream bank stabilization in progress.

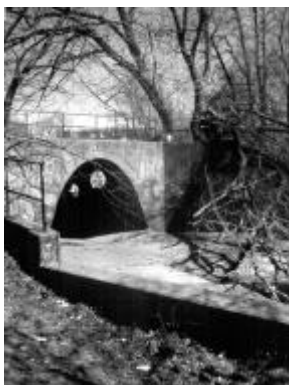
*Outfall structure,
Tacony Creek Park*

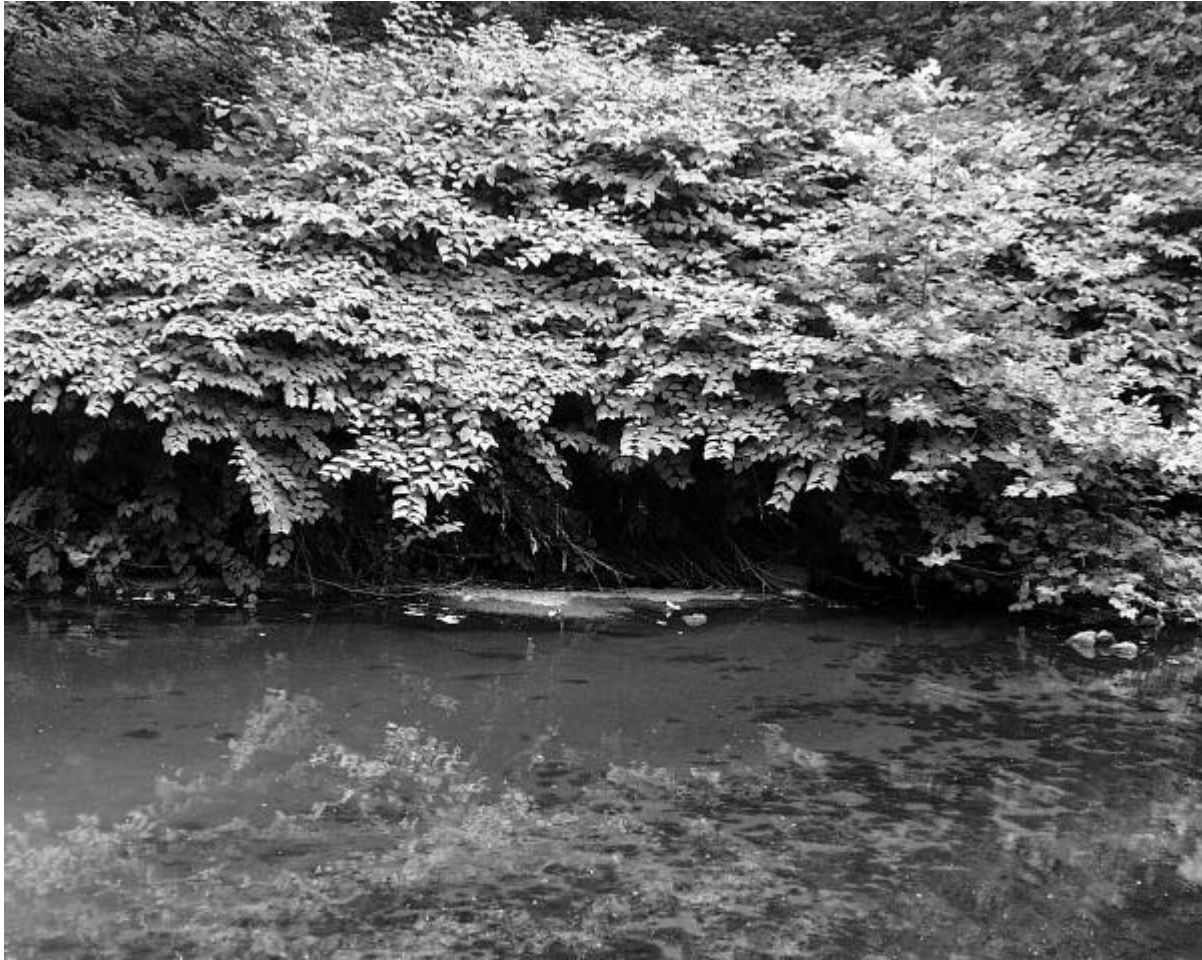
Knotweed in Tacony Creek Park.

Invasive Plants. Non-native invasive plants were found throughout Tacony Creek Park. A large stand of the invasive plant Kudzu is located at 'I' and Ramona streets. Japanese knotweed is found along the length of the stream in the park. FPC staff and volunteers have been working to eliminate the knotweed along the west bank of the stream, north of Rising Sun Avenue.

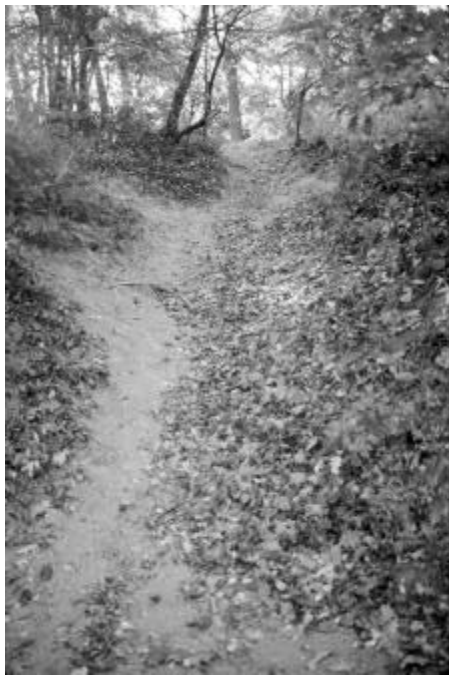
Eroding slope, Tacony Creek Park.

Many of the slopes in the park have been severely eroded due to overuse by mountain bikes, motorized vehicles, trash dumping and stormwater runoff from adjacent streets. Activities which disturb the soil aid in eroding the slopes, which will make them unstable and unable to support vegetation. Once the slopes lack cover, the erosion continues. Stormwater runoff exacerbates the problem and creates gullies along the slopes, which serve as obstacle courses for ATVs.

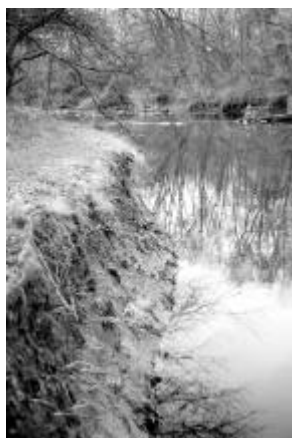
Bank erosion.

that they are no longer able function as they should. Due to this disturbance, an exotic plant species, Japanese knotweed (*Polygonum cuspidatum*) has invaded the banks of the creek. In Tacony Creek Park, volunteer efforts are presently underway to eradicate this species from riparian zones, but it is still propagating along the mainstem of Tacony Creek and is particularly dense along banks near Adams Avenue and the area north of Rising Sun Avenue on the east bank. This plant reproduces vegetatively through rhizomes and is able to outcompete native riparian vegetation. It has a shallow root mass and therefore is not able to stabilize the banks as effectively as native tree species could. This makes the banks more vulnerable to erosion during a storm event. The more soil that becomes exposed, the more area this plant has to invade. Management techniques to rid the banks of this plant include cutting and removing the root to spraying with herbicide such as Rodeo, which is approved for use near water. The restoration activities for riparian zones in this project include removing Japanese knotweed, regrading the banks and replanting with native forest corridors at least 35 feet in width to serve as a functional riparian zone.

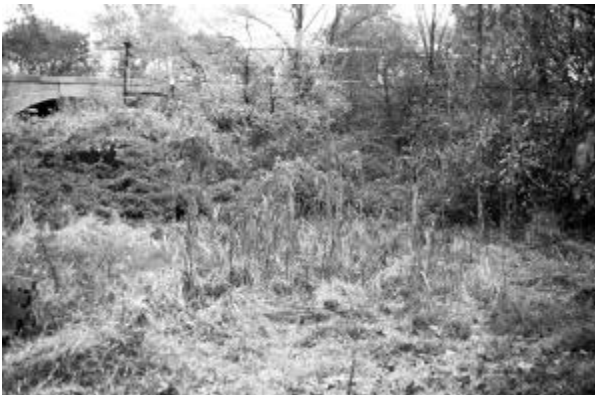
Wetlands off Adams Avenue, Tacony Creek Park.

Wetlands can either be created, which involves constructing a wetland where no wetland has existed before on that site, or they can be restored by rehabilitating an existing degraded wetland. Restoration of a wetland often involves reestablishing the vegetation. The vegetation to be planted depends on the type of wetland desired, the region, and the climate. Hydrology is the most important variable. If the proper hydrologic conditions are developed, the chemical and biological aspects will respond accordingly.

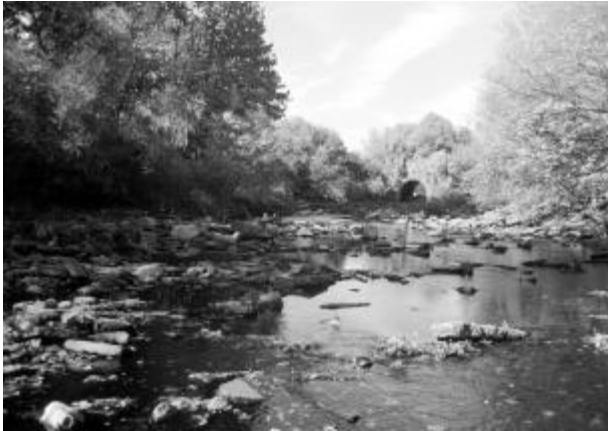
Main stem of Tacony Creek.

Proposed restorations were classified as “channel” type if the activity is intended to restore a stream within its channel or along its banks. The types of “channel” restoration actions include: protect/enhance, trash removal, bank stabilization/regrade/riparian, modify channel, infiltration/berms, detention basin, daylighting, dam modification, dam removal, structural improvements (trails and stormwater), and fish reintroduction. A given restoration site may involve one or more of these actions, depending on site-specific conditions (see Section 2.E). The overriding objective for channel restoration is to improve in-stream habitat to a more natural state. As
