5. PENNYPACK PARK MASTER PLAN

Fairmount Park System

Natural Lands Restoration

Master Plan

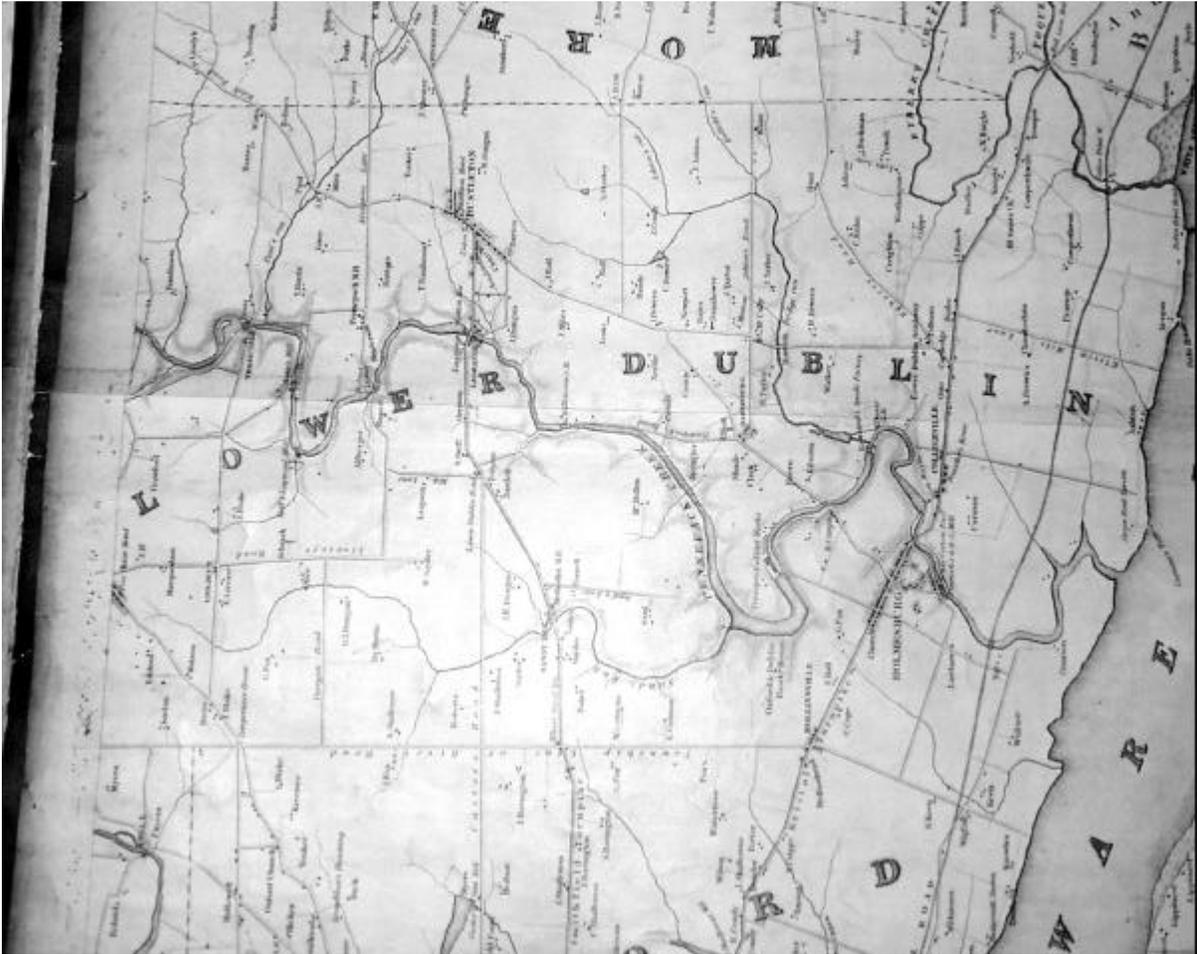
Figure 5.B.1. Other than the numerous mill sites along Pennypack Creek, in 1839 the stream valley remained rural (Ellet Map, 1839).

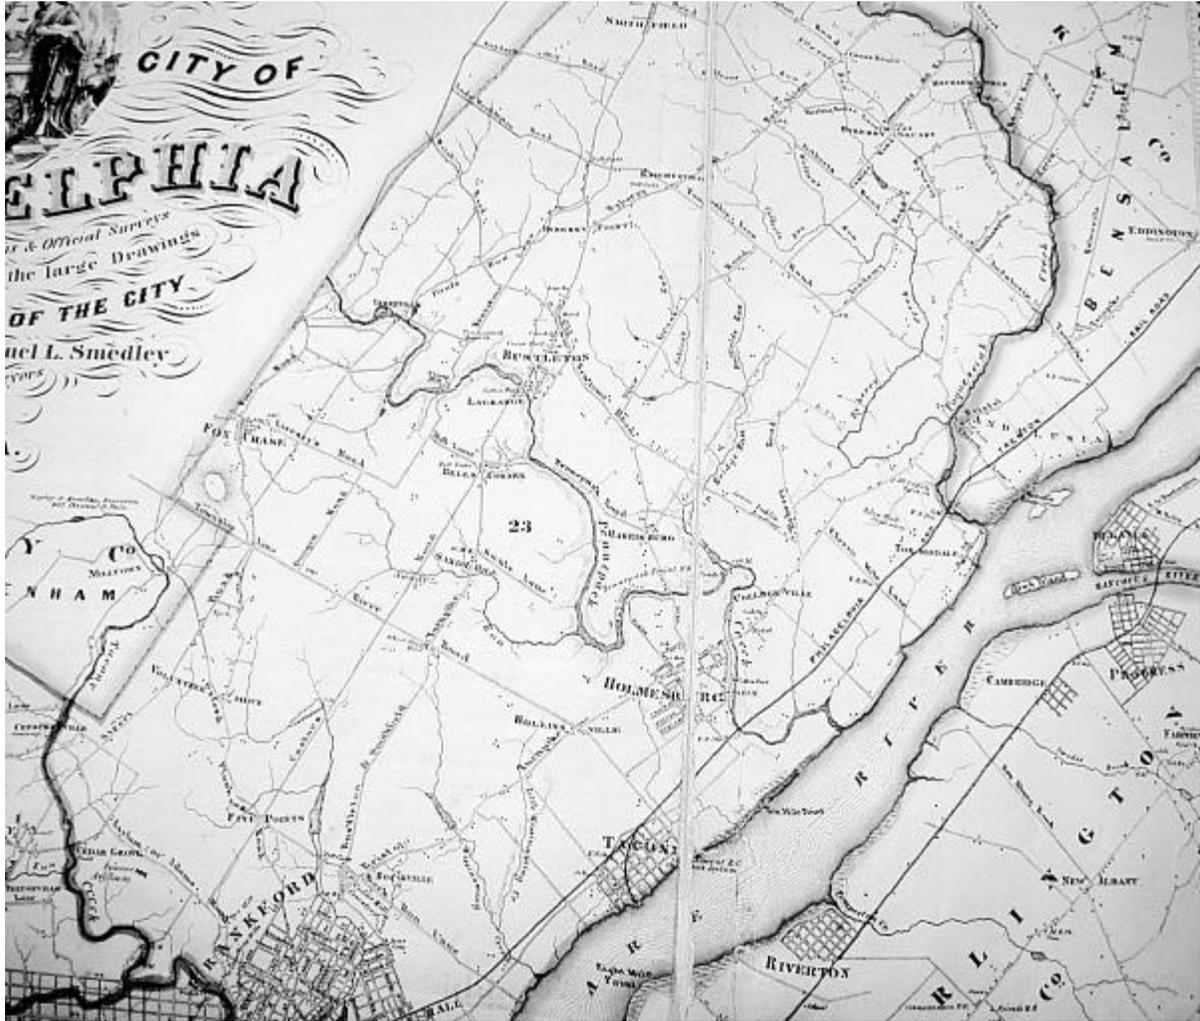
Figure 5.B.2. The Smedley map of 1863 shows the Pennypack Creek and tributaries with numerous industrial sites.

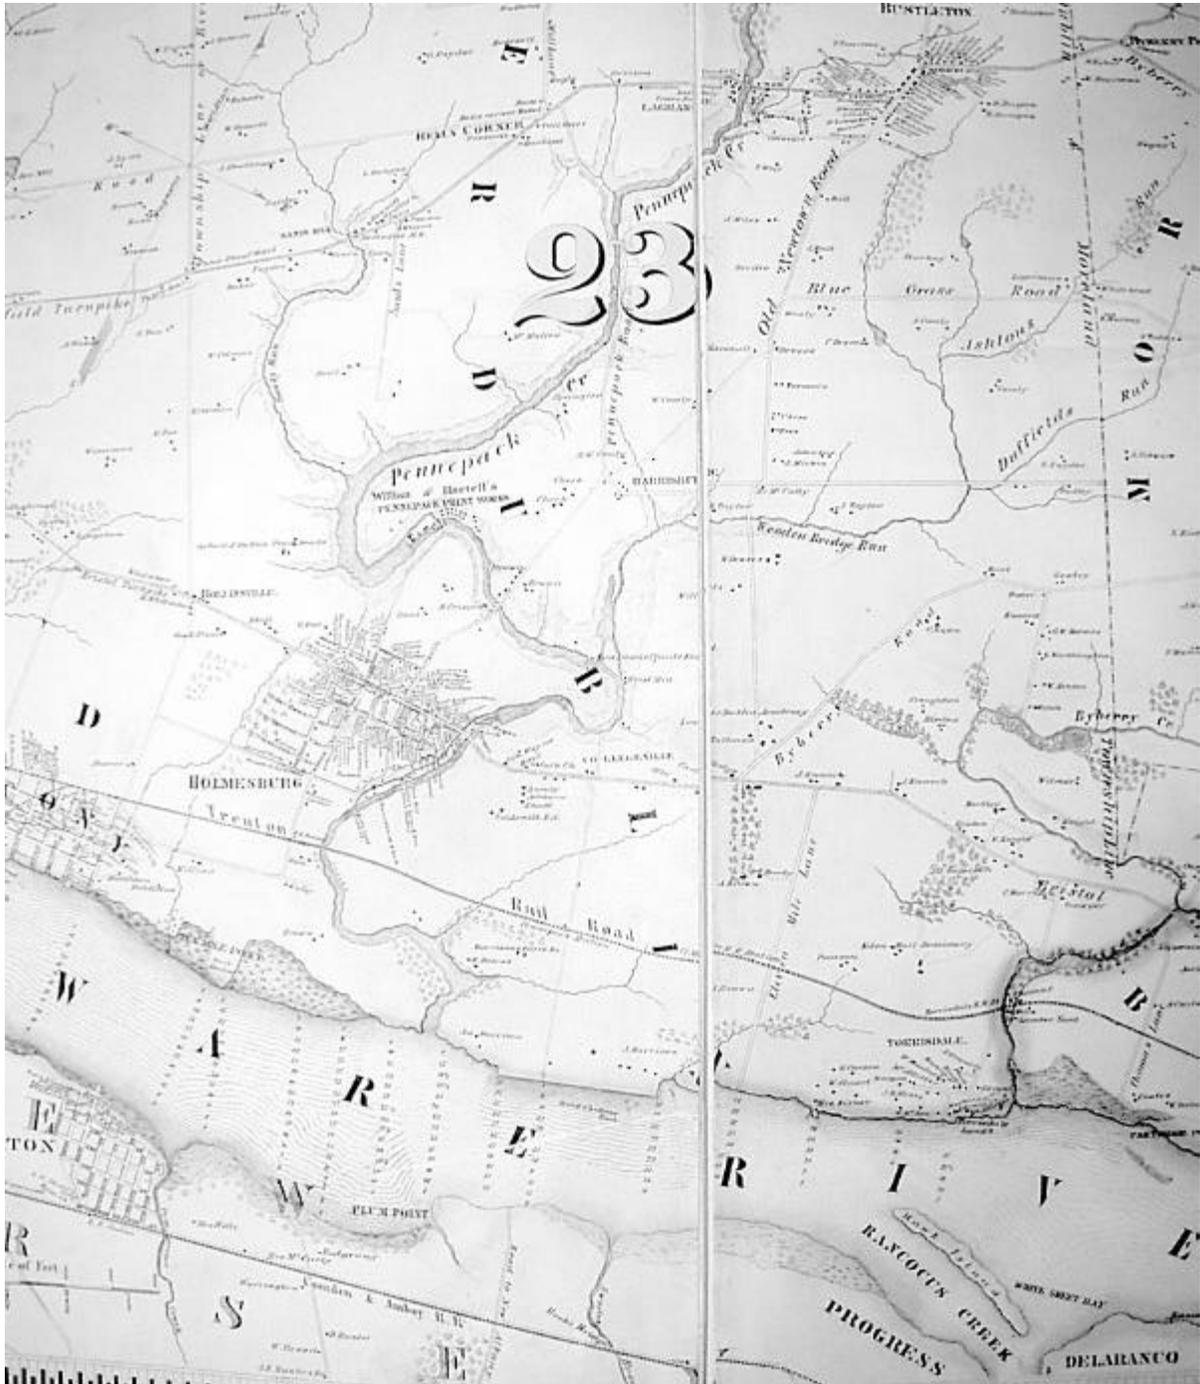
Figure 5.B.3. Detail of the Smedley map of 1863 showing the mouth of Pennypack Creek.

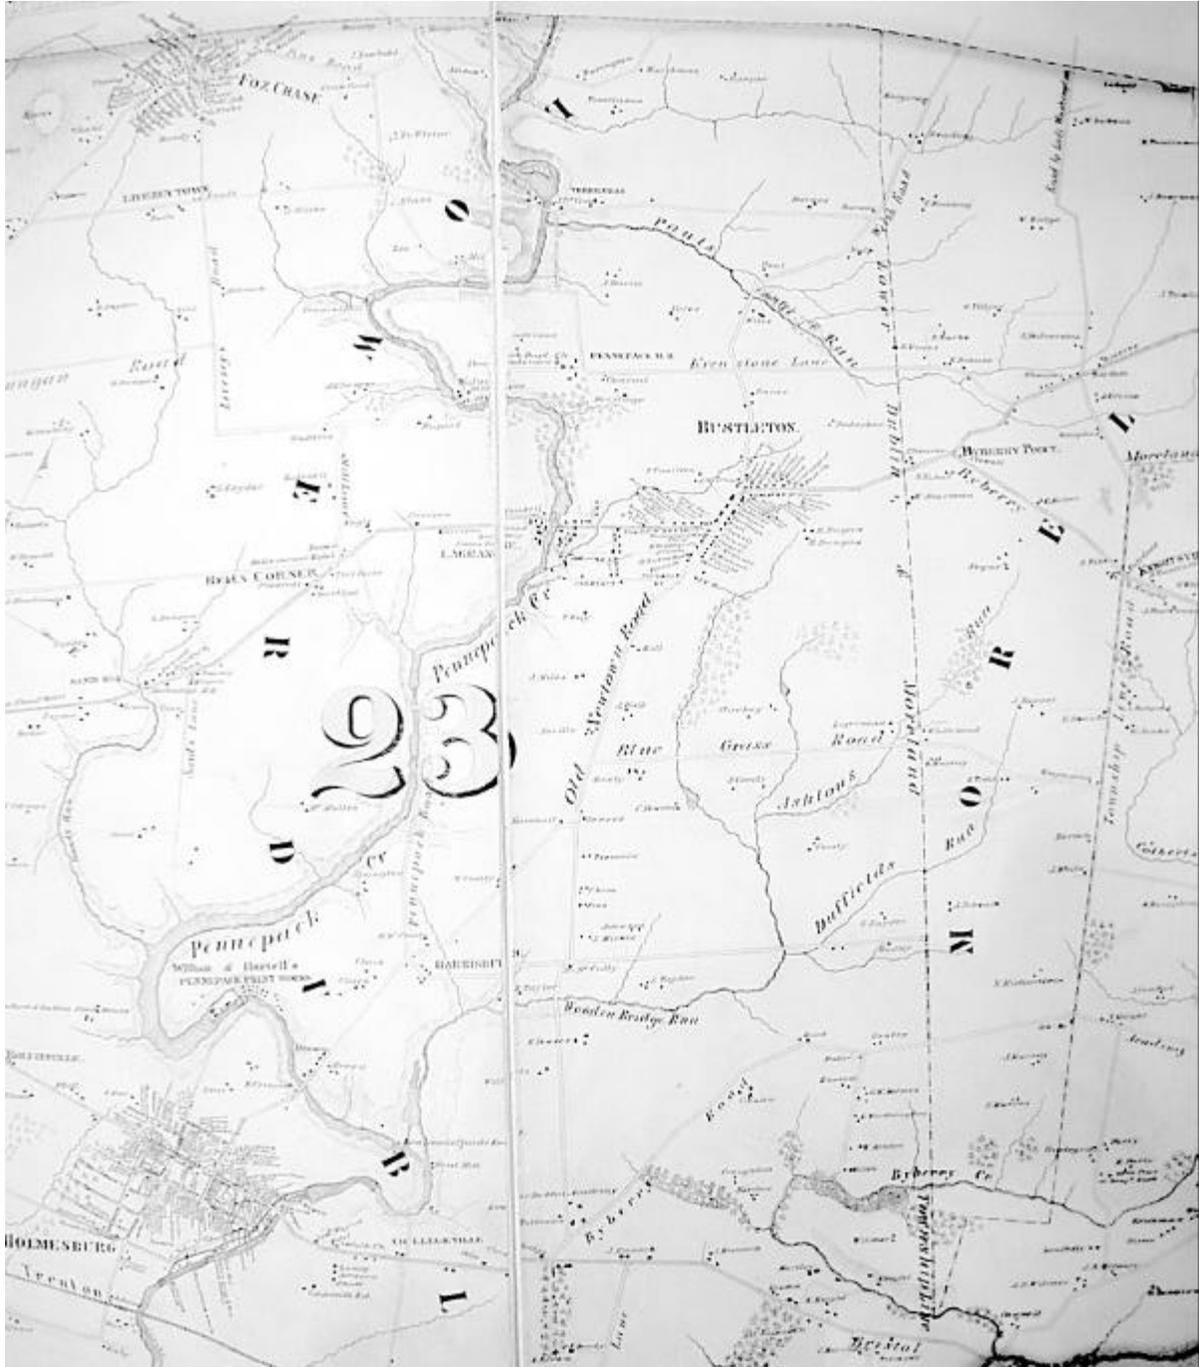
Figure 5.B.4. Detail of the Smedley map of 1863 showing the upper portion of Pennypack Creek in Philadelphia.

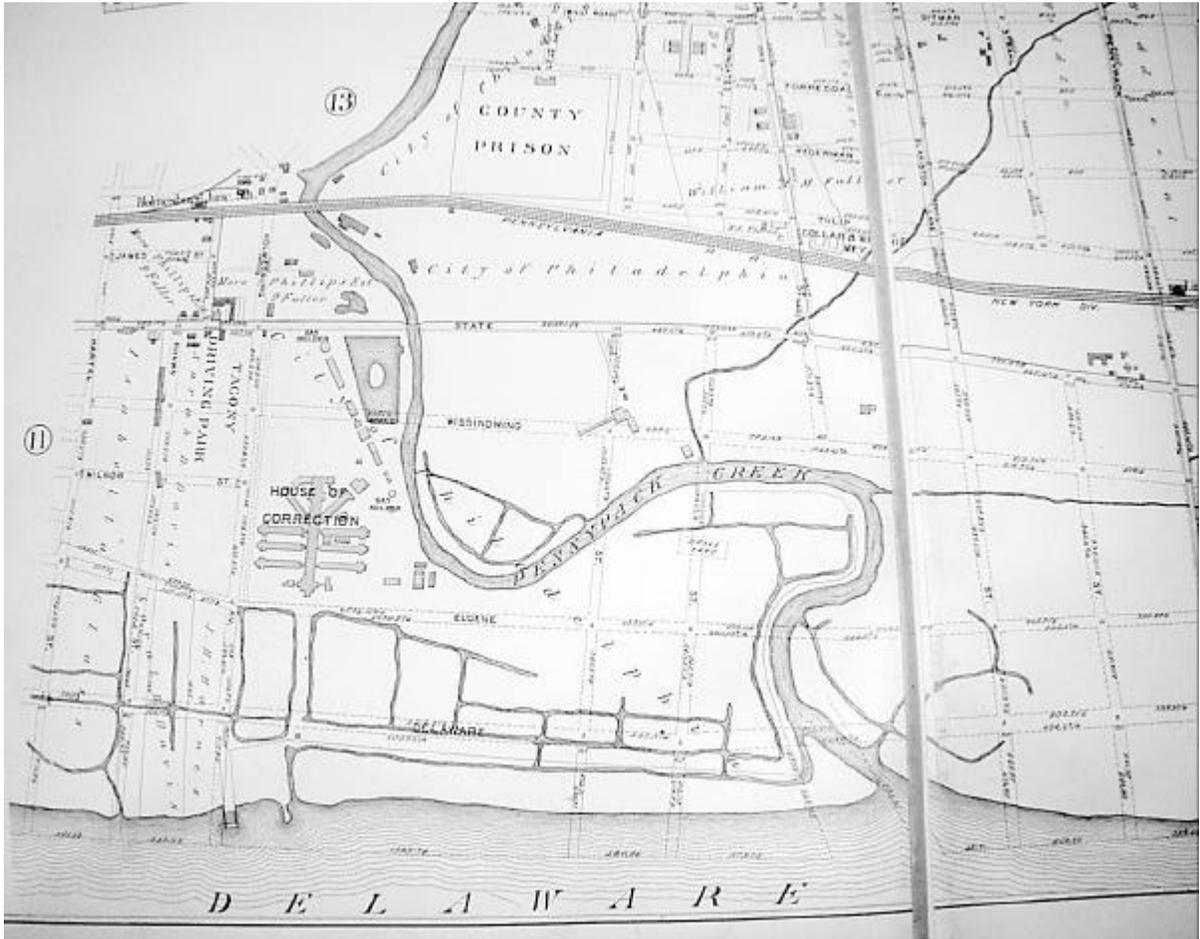
Figure 5.B.5. The Bromley map of 1894 shows that the mouth of Pennypack Creek began to develop dramatically at the turn of the century.

Between 1863 and 1894 (Fig. 5.B.5), the Pennypack stream valley developed dramatically. The area was designed on city maps, including roads extending the rigid geometry of the city to the countryside now poised for development. It was during the mid 19th century that part of lower Dublin Township became part of the City of Philadelphia and the stage was set for the expansion and development of the agricultural lands as an extension of the city. At the mouth of the Pennypack Creek, a new landscape emerged. Channels or ditches, along with dikes approximately 20-30 feet in width, were constructed near the river's edge. It is presently unclear how these structures functioned in the industrial landscape. However, it is clear that by 1896 the mouth of the Pennypack Creek was developed and was no longer primarily agricultural. The upper reaches were ready for expansion of the city. Nonetheless, the Pennypack Creek was one of the last of the Philadelphia watersheds to be developed, remaining a rural landscape well into the 20th century (Bromley 1910). In the early 20th century, some farms were turned into country estates, but much of the land remained open. Aerial and ground photographs (Miller et al. 1983) from 1910-1930 show new roads being laid out into open farmlands with a few clusters of new developments. Even by 1940, the Pennypack valley was not fully developed (Miller et al. 1983).

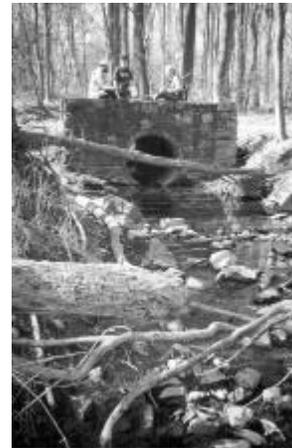
A stream in Pennypack Park impacted by stormwater.

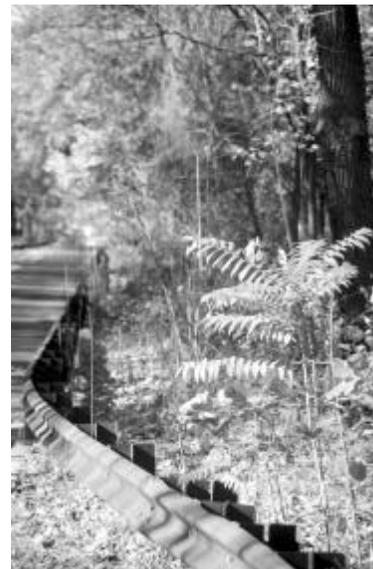
Exotic trees thrive on the edge of the woods and can out compete native species.

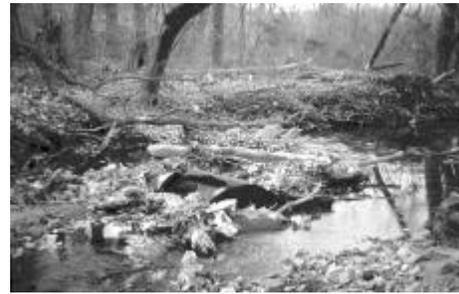
Debris in Ballard Run.
