7. POQUESSING CREEK PARK MASTER PLAN

Fairmount Park System

Natural Lands Restoration

Master Plan

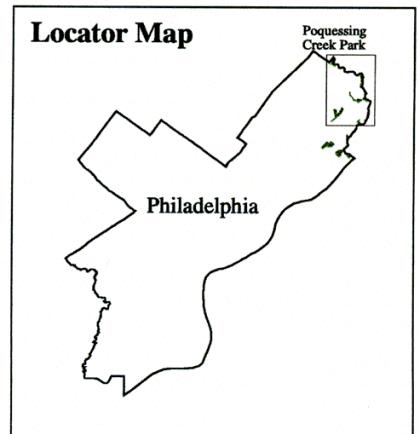
Map 1 of 2

POQUESSING CREEK PARK Natural Lands Restoration Master Plan RESTORATION SITES

A list of specific sites where restoration is recommended is presented, along with maps showing the location of each area. A description of each site and recommended activities for each site are presented in the appendix to the plan. The plan also contains an explanation of techniques and options for the various types of restoration activities (e.g., control of exotics, replanting, gully repair) that are identified. Restoration actions which are broadly applicable throughout the park are identified. These relate to overall operations in the park, particularly those involving management of the borders between the designed and natural lands. Some of these are outside the direct purview of NLREEP and should be implemented in cooperation with other groups.
